# Manhole Inspection Summary

Manhole # S33GG\_022MH

Insp Date: **2/15/07 12:12 PM**

**Location** Address: **11 MT ROYAL AVE**

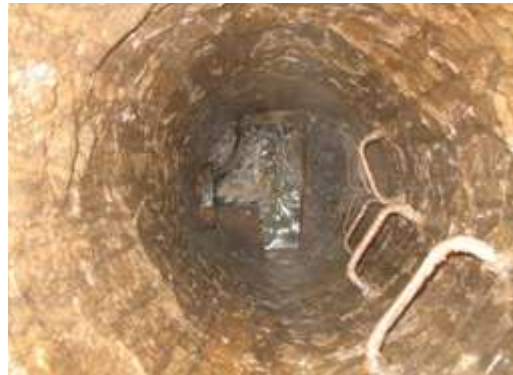
Top View

☒ **Corroded**

Corroded steps.

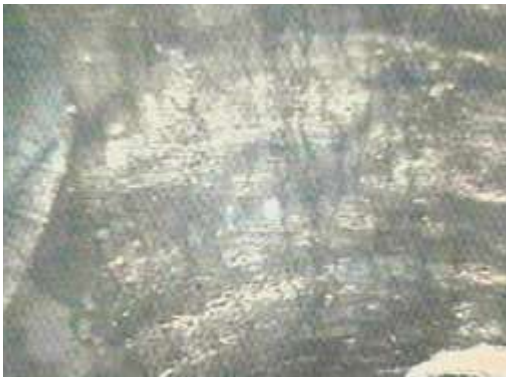
Defect

☒ **Wall**

Barrel infiltration.

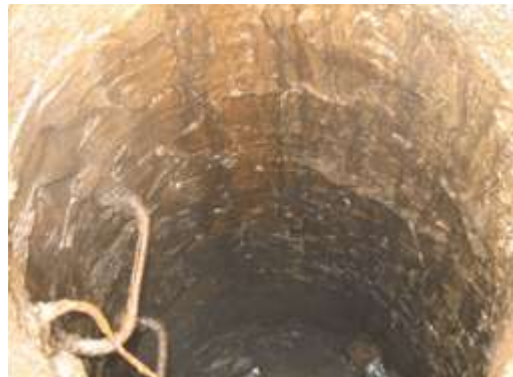
Defect

☒ **Leaks**

☒ **Joint**

Adjustment infiltration.
